BOARDWALK COMMONS AT WINGHAVEN

SITE PLAN
Design By: G.A.S.
Drawn By: K.L.A.
P. 6500-35
Checked By: T.J.M.
4-29-02

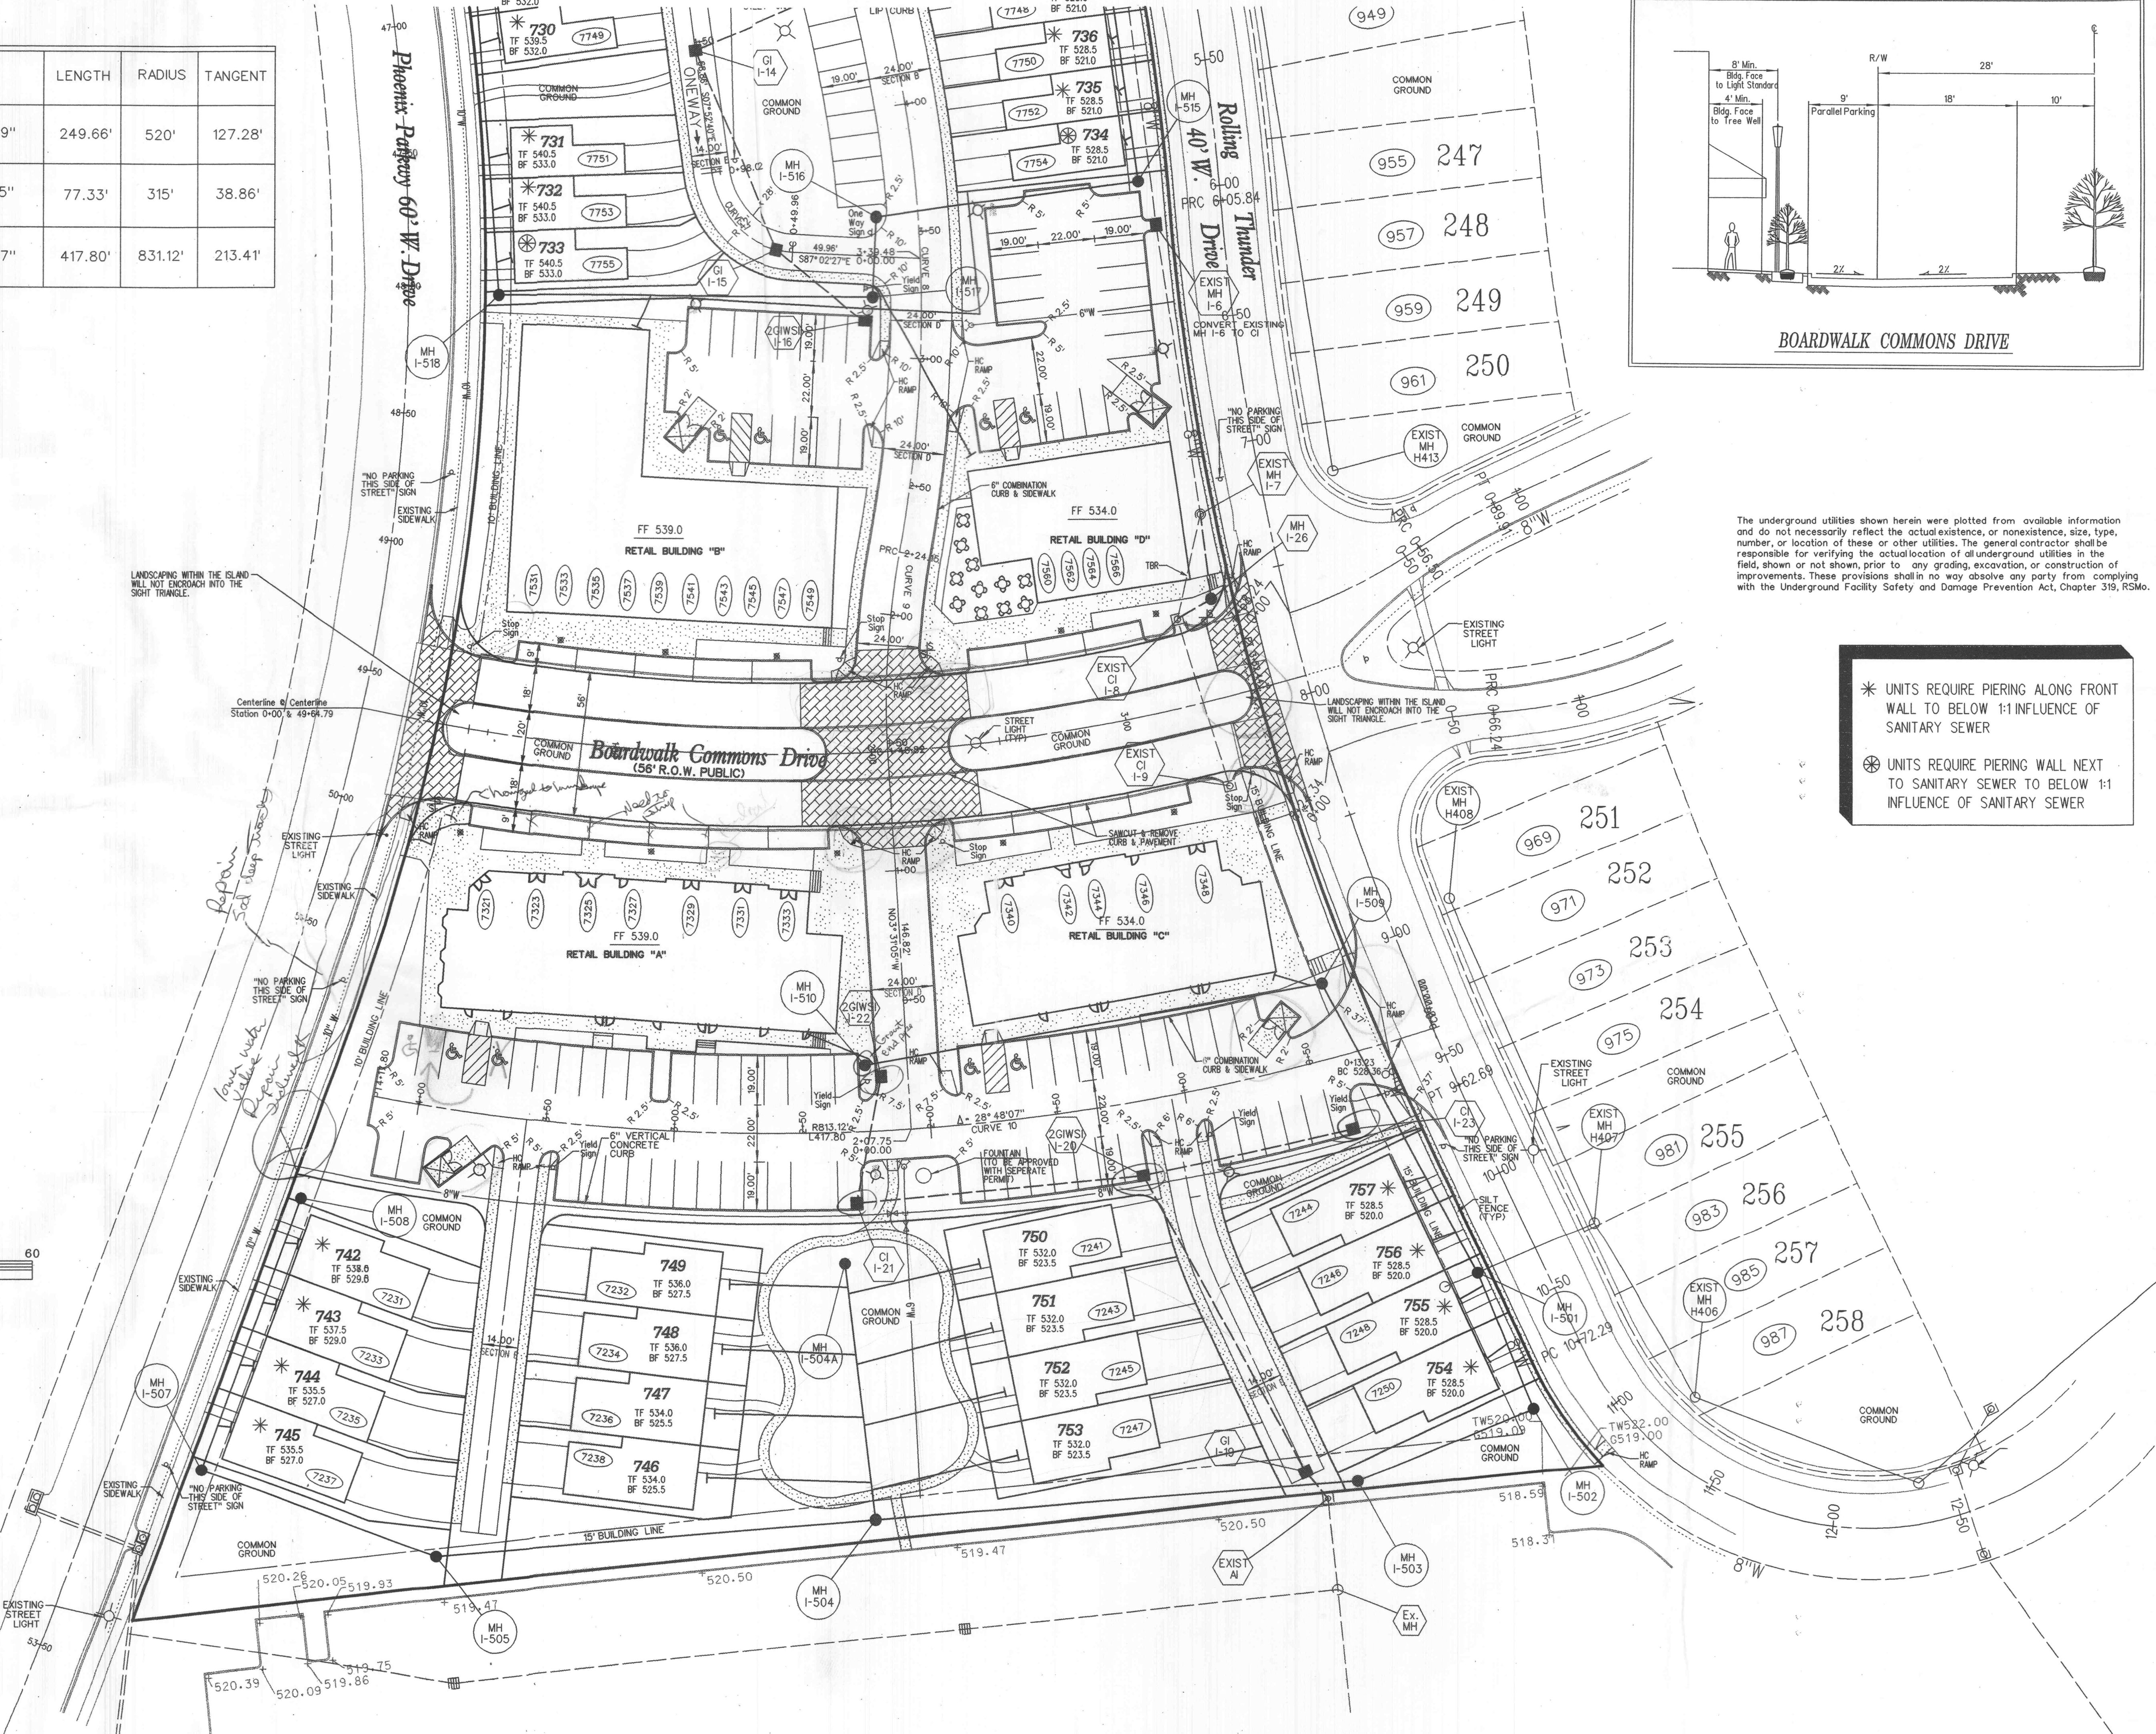
BOARDWALK COMMONS DRIVE

- * UNITS REQUIRE PIERING ALONG FRONT WALL TO BELOW 1:1 INFLUENCE OF SANITARY SEWER
- ⊗ UNITS REQUIRE PIERING WALL NEXT TO SANITARY SEWER TO BELOW 1:1 INFLUENCE OF SANITARY SEWER

LANDSCAPING WITHIN THE ISLAND WILL NOT ENCRUCH INTO THE SIGHT TRIANGLE.

*Repair
Sod deep
Sod
Lawn with
Drip
Irrigation*

Centerline @ Centerline
Station 0+00 & 49+64.79
