**THE VILLAS AT ARAGON**  
 VETERANS MEMORIAL PARKWAY  
 OF FALLON, MO 63366

**EXISTING CONDITIONS & NATURAL RESOURCES PLAN**  
 Design By: R/LH  
 Drawn By: R/LH  
 Checked By: R/LH  
 Permit No. GR22-00001  
 Volz Project # 22649  
 10-12-22  
 C04

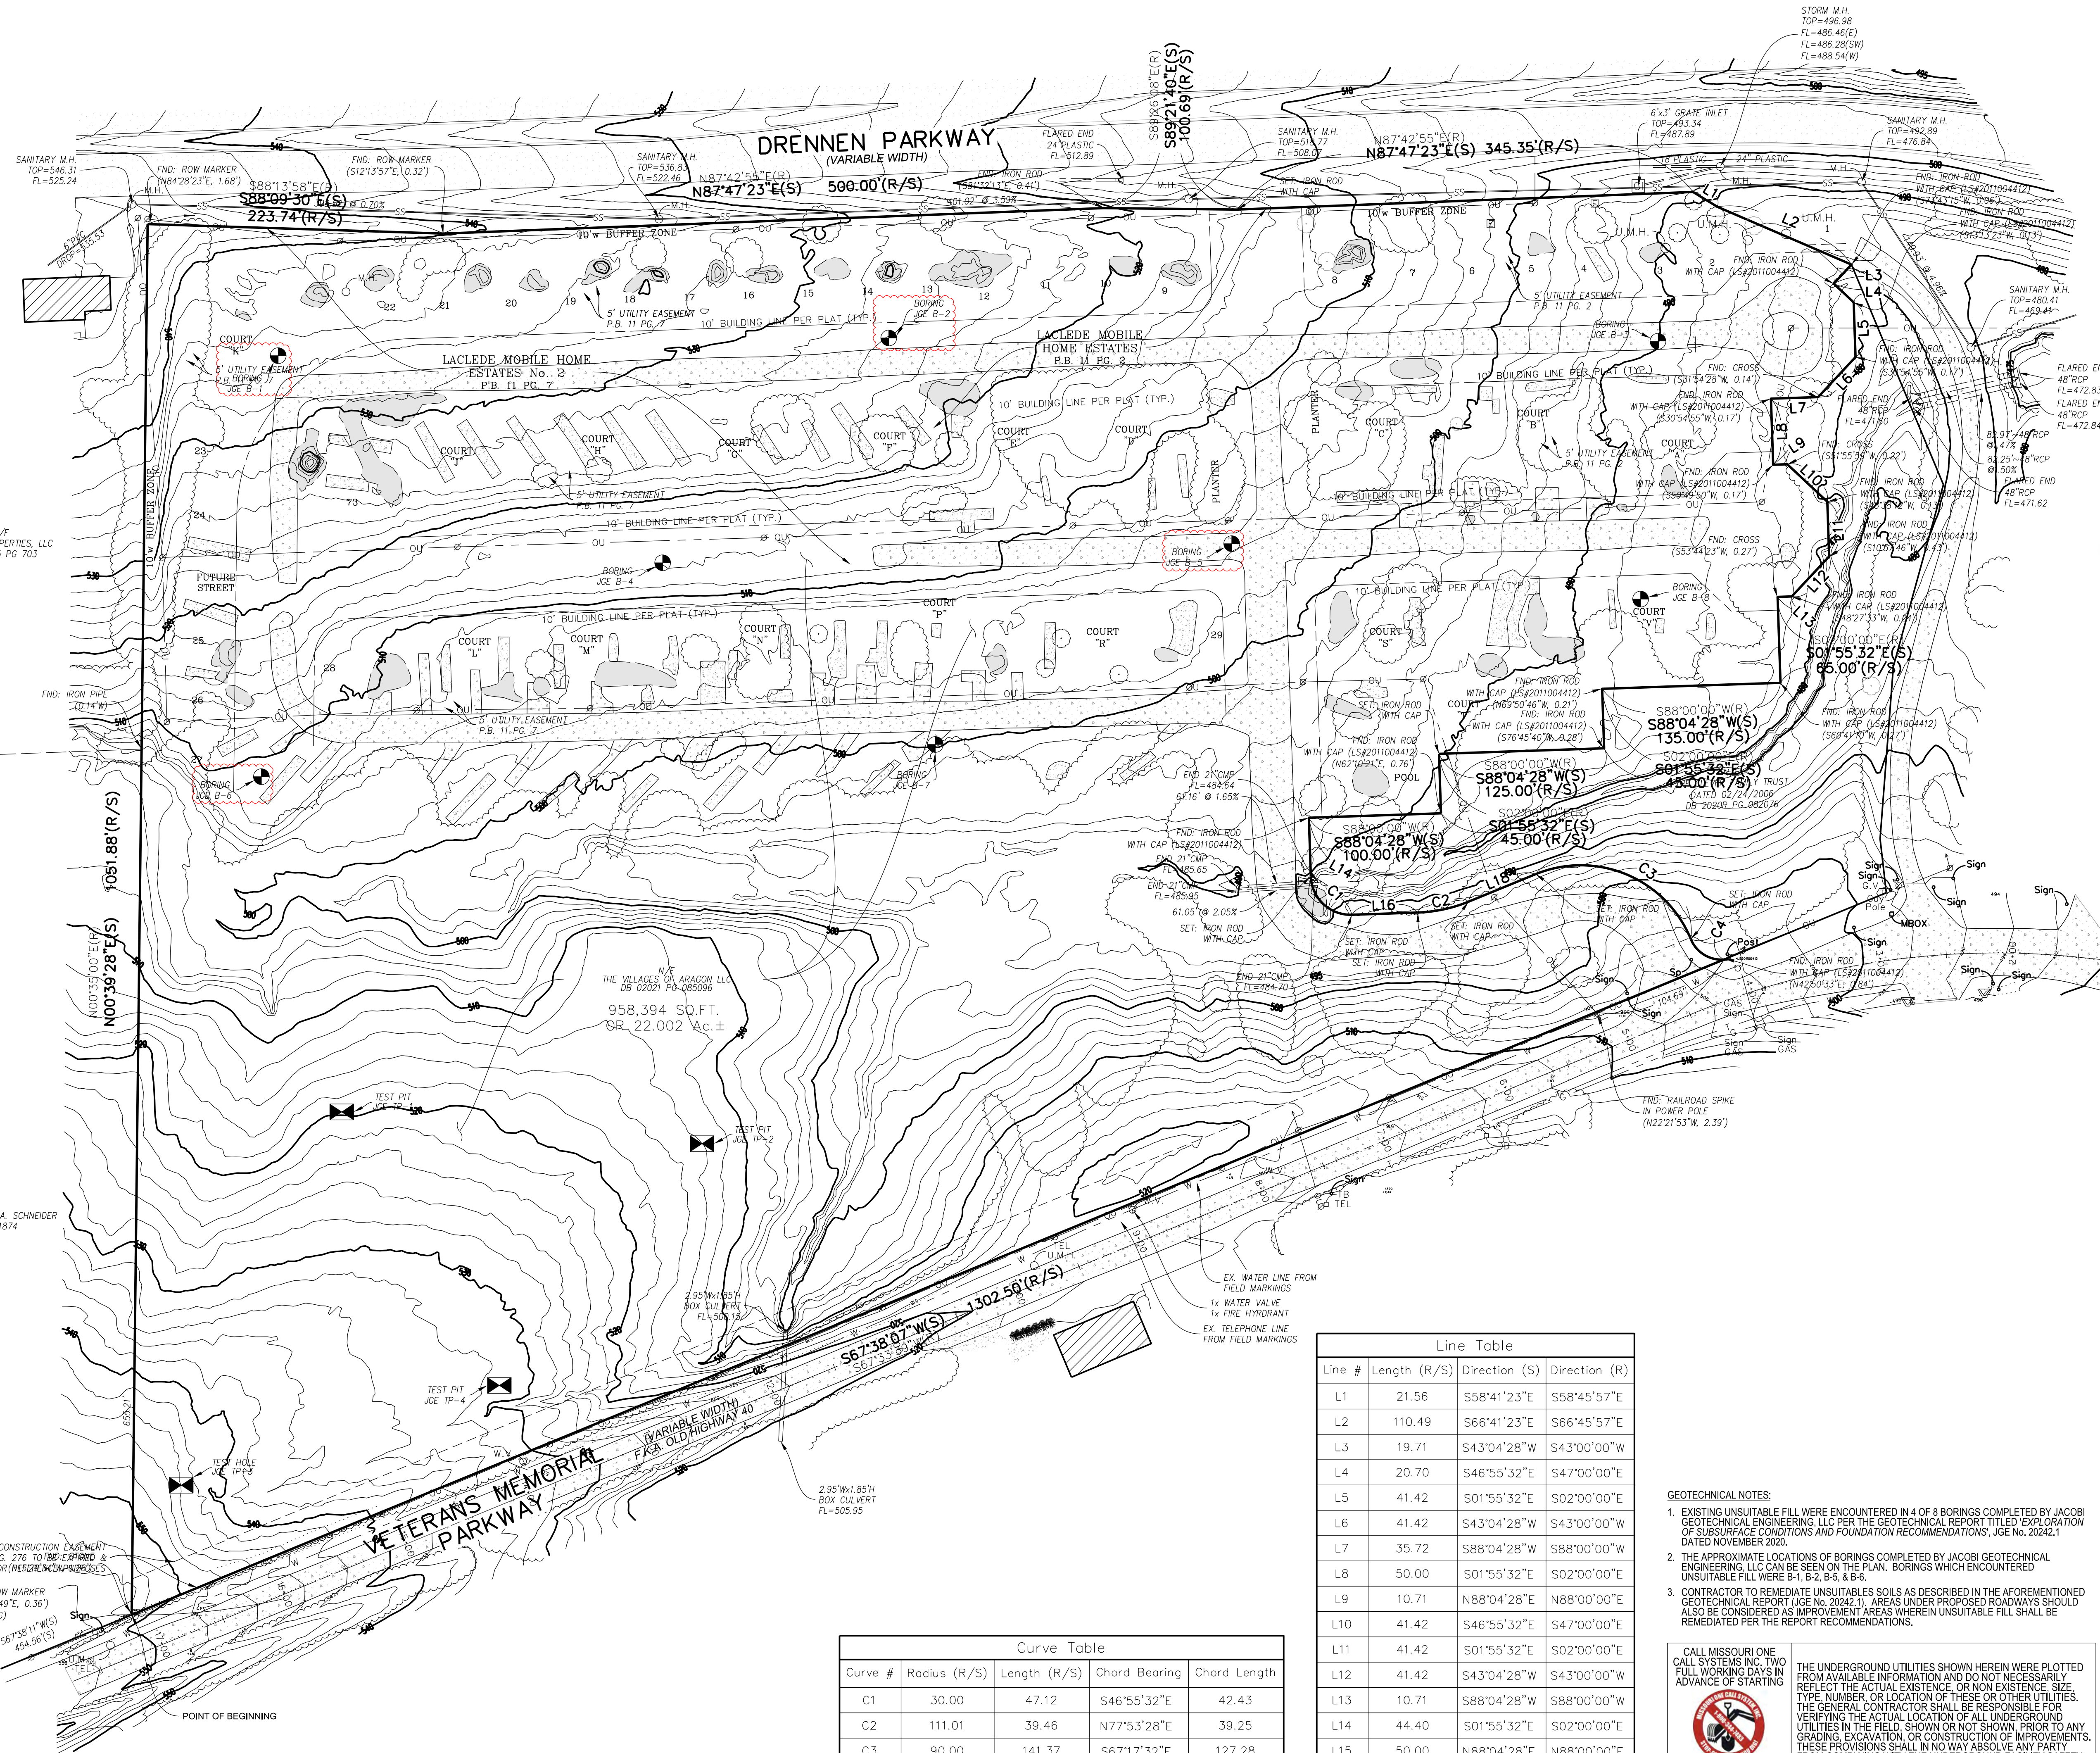
- EXISTING UNSUITABLE FILL WERE ENCOUNTERED IN 4 OF 8 BORINGS COMPLETED BY JACOBI GEOTECHNICAL ENGINEERING, LLC PER THE GEOTECHNICAL REPORT TITLED "EXPLORATION OF SUBSURFACE CONDITIONS AND FOUNDATION RECOMMENDATIONS", JGE NO. 20242.1 DATED NOVEMBER 2020.
- THE APPROXIMATE LOCATIONS OF BORINGS COMPLETED BY JACOBI GEOTECHNICAL ENGINEERING, LLC CAN BE SEEN ON THE PLAN. BORINGS WHICH ENCOUNTERED UNSUITABLE FILL WERE B-1, B-2, B-5, & B-6.
- CONTRACTOR TO REMEDIATE UNSUITABLE SOILS AS DESCRIBED IN THE AFORESAID GEOTECHNICAL REPORT (JGE NO. 20242.1), AREAS UNDER PROPOSED ROADWAYS SHOULD ALSO BE CONSIDERED AS IMPROVEMENT AREAS WHEREIN UNSUITABLE FILL SHALL BE REMEDIATED PER THE REPORT RECOMMENDATIONS.
