RE: Utility Trench Backfill Testing Services

Hillmann Place II O'Fallon, Missouri SCI No. 2011-0132.00

### **COMPACTION TEST REPORT**

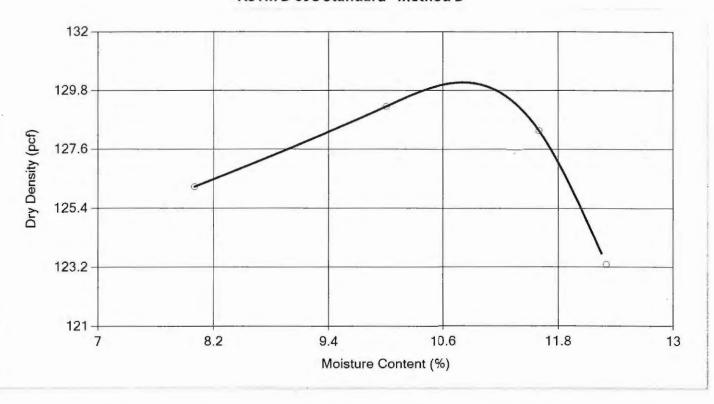
ASTM D 698 Standard - Method B

Maximum Dry Density (pcf):

130.1

Optimum Moisture Content: 10.8%

1	2	3	4	5	6
Weight of Mold and Soil (g)	6,262.5	6,350.8	6,366.0	6,295.5		
Weight of Mold (g)	4,214.5	4,214.5	4,214.5	4,214.5	, , , , , , , , , , , , , , , , , , ,	
Weight of Wet Soil & Tare (g)	688.2	782.2	728.4	954.5	- Australian	
Weight of Dry Soil & Tare (g)	645.6	718.7	661.9	859.6		
Weight of Tare (g)	110.4	85.8	86.3	86.8		
Moisture Content (%)	8.0	10.0	11.6	12.3		
Dry Density (pcf)	126.2	129.2	128.3	123.3		***************************************
