McEagle Development
100 HONOLULU SPRINGS PLACE
OTULALO, HI 96866
TEL: (808) 564-9900
FAX: (808) 564-9901

AT WINGHAVEN

BRISTOL

CONSTRUCTION DETAILS
Design By: JLF
Drawn By: JRS
Checked By: JLF
B5930-33
12-12-02
8

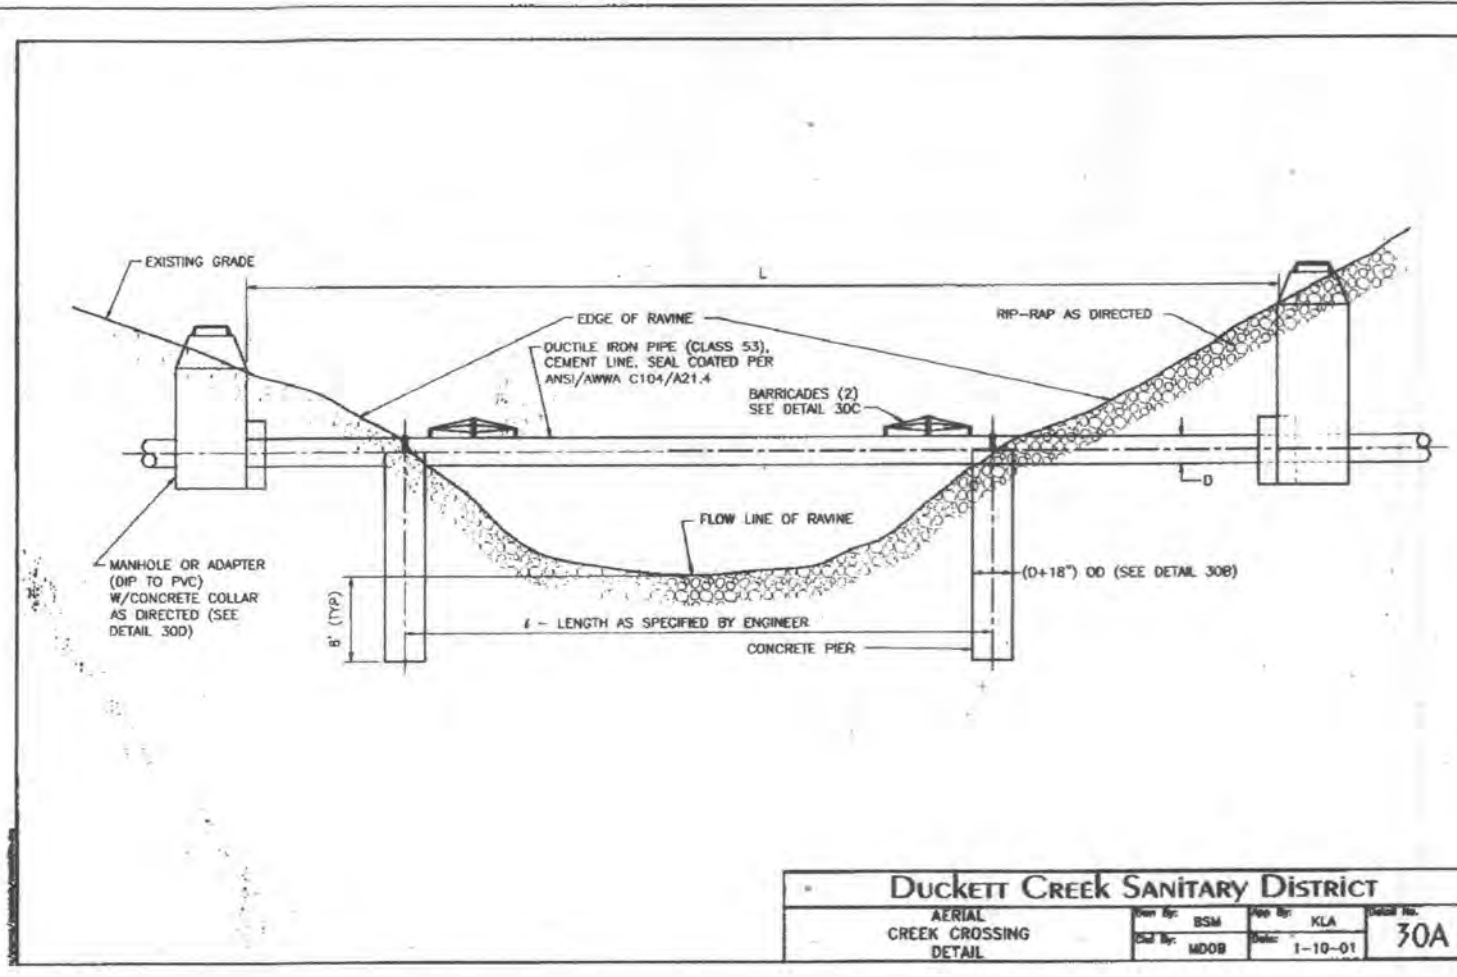
Duck Creek Sanitary District
AERIAL CROSSING
DETAIL
DATE: 1-19-01
JOB NO: 70A
